**U.S. EPA REGION VIII
TECHNICAL ENFORCEMENT PROGRAM
RCRA CORRECTIVE ACTION ASSESSMENT REPORT**

Facility: ASARCO East Helena Plant
100 Smelter Road
East Helena, MT

Inspection Type: Corrective Action Assessment Inspection

Date: March 7, 2007

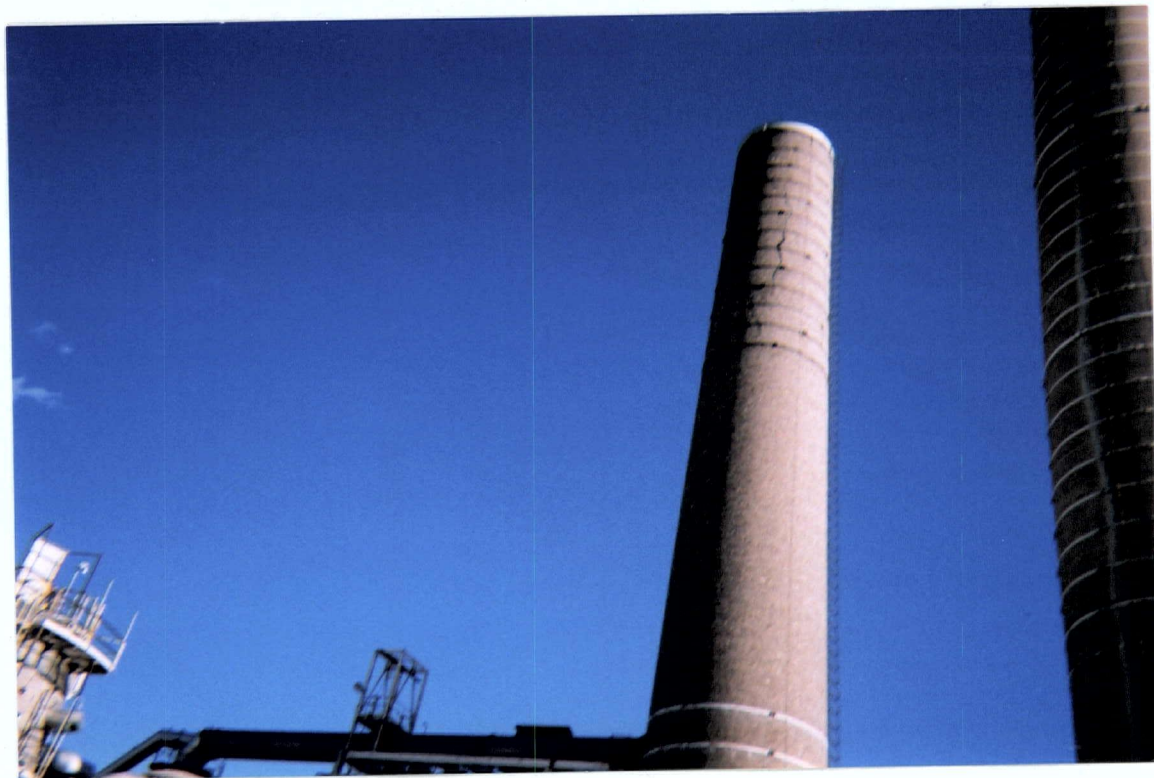
Roll 1, Photo 25; Facility: ASARCO East Helena Smelter; Subject: Acid Plant Brick Stack; Photographer: Linda Jacobson; Date: March 7, 2007

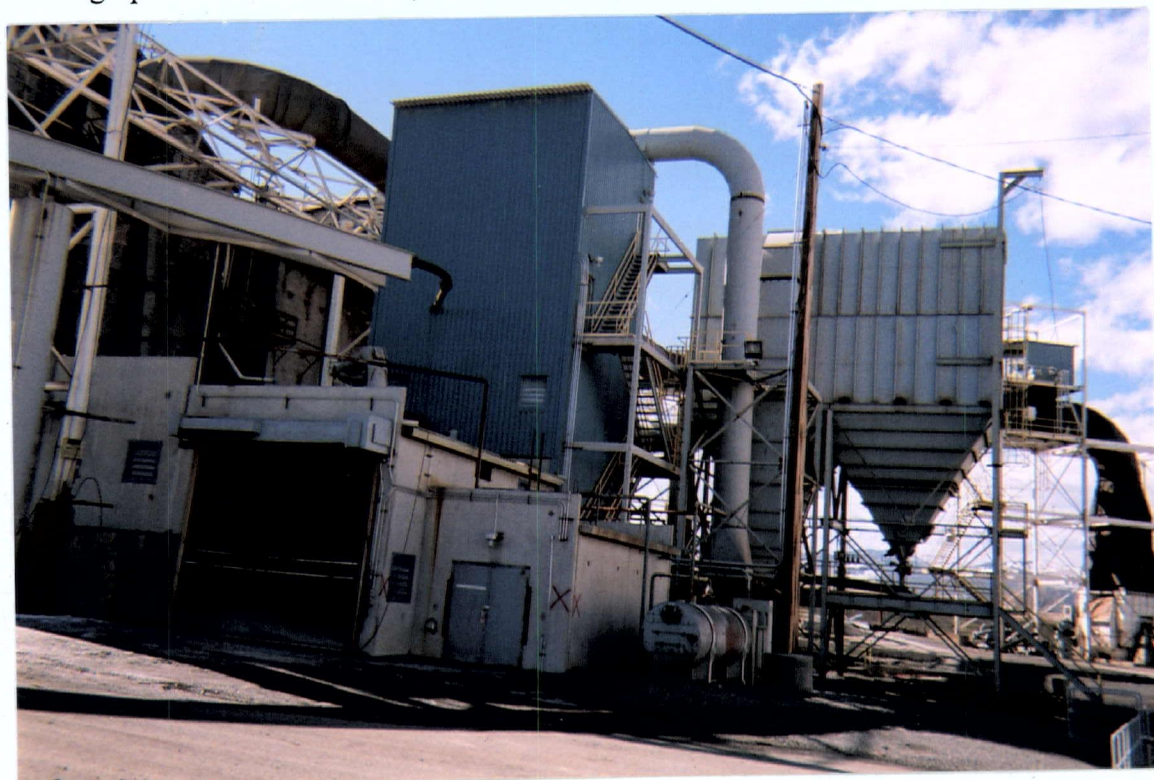
Roll 1, Photo 26; Facility: ASARCO East Helena Smelter; Subject: Baghouse Building; Photographer: Linda Jacobson; Date: March 7, 2007

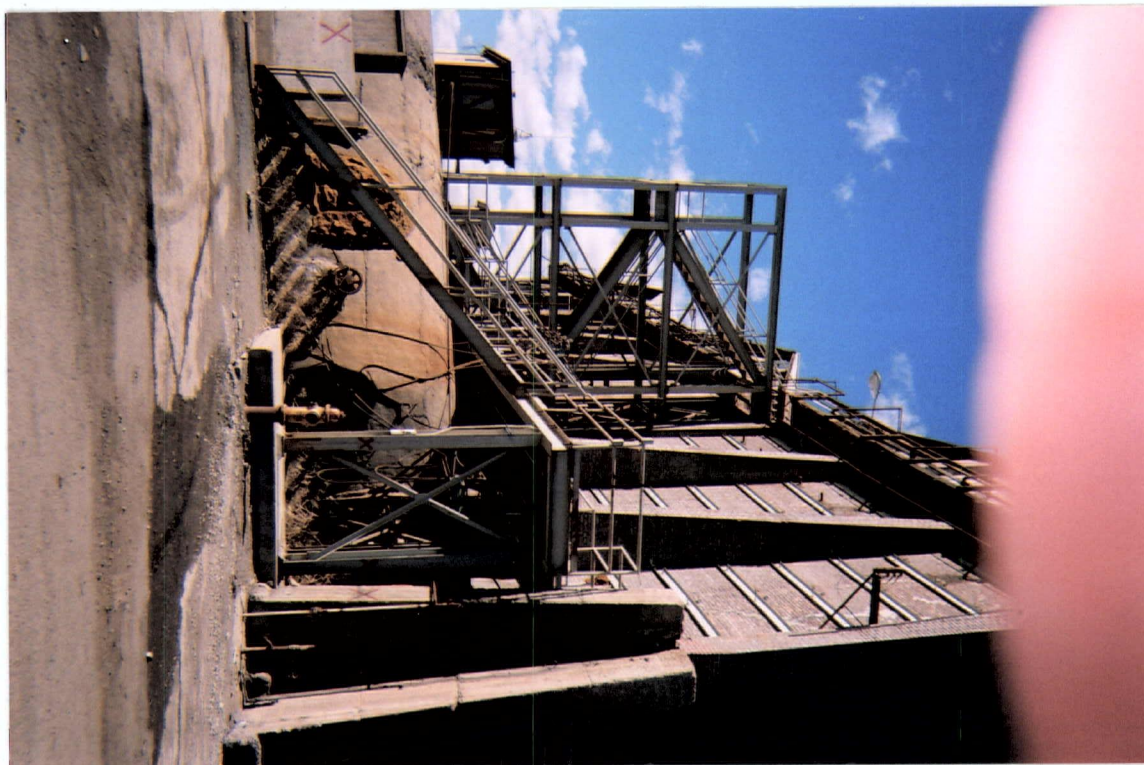
Roll 1, Photo 27; Facility: ASARCO East Helena Smelter; Subject: Baghouse; Photographer: Linda Jacobson; Date: March 7, 2007

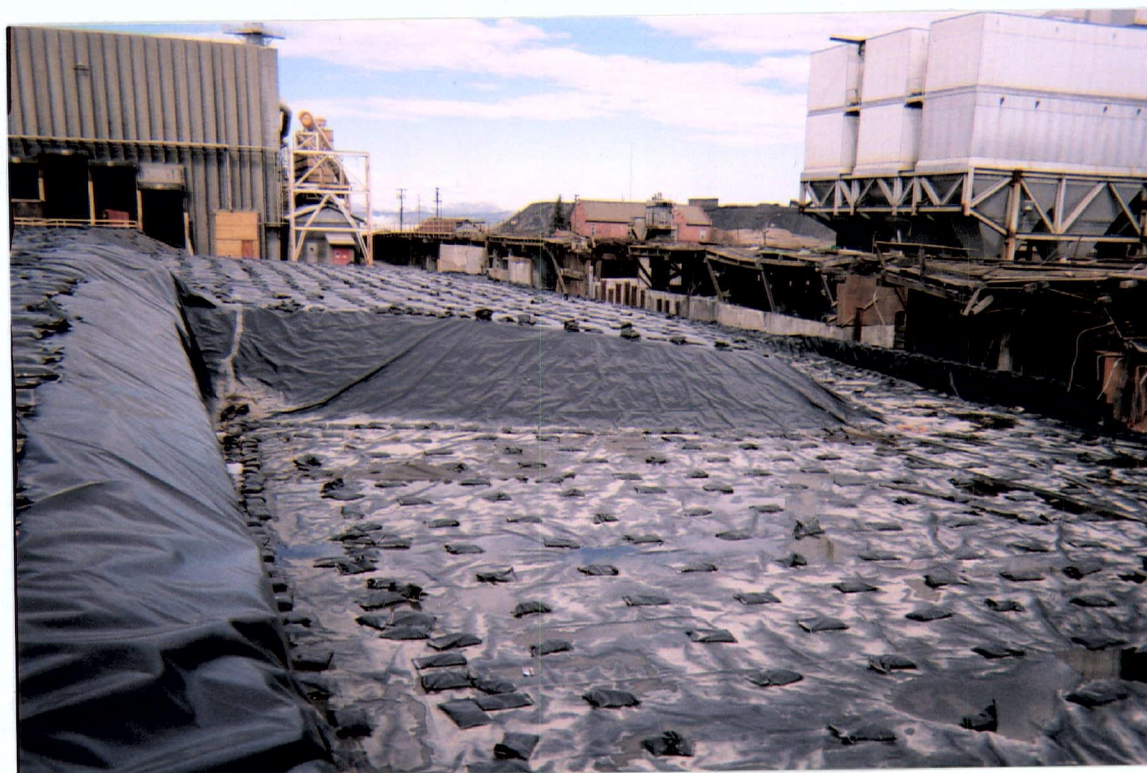
Roll 2, Photo 1; Facility: ASARCO East Helena Smelter; Subject: Sinter Plant Temporary Cap; Photographer: Linda Jacobson; Date: March 7, 2007

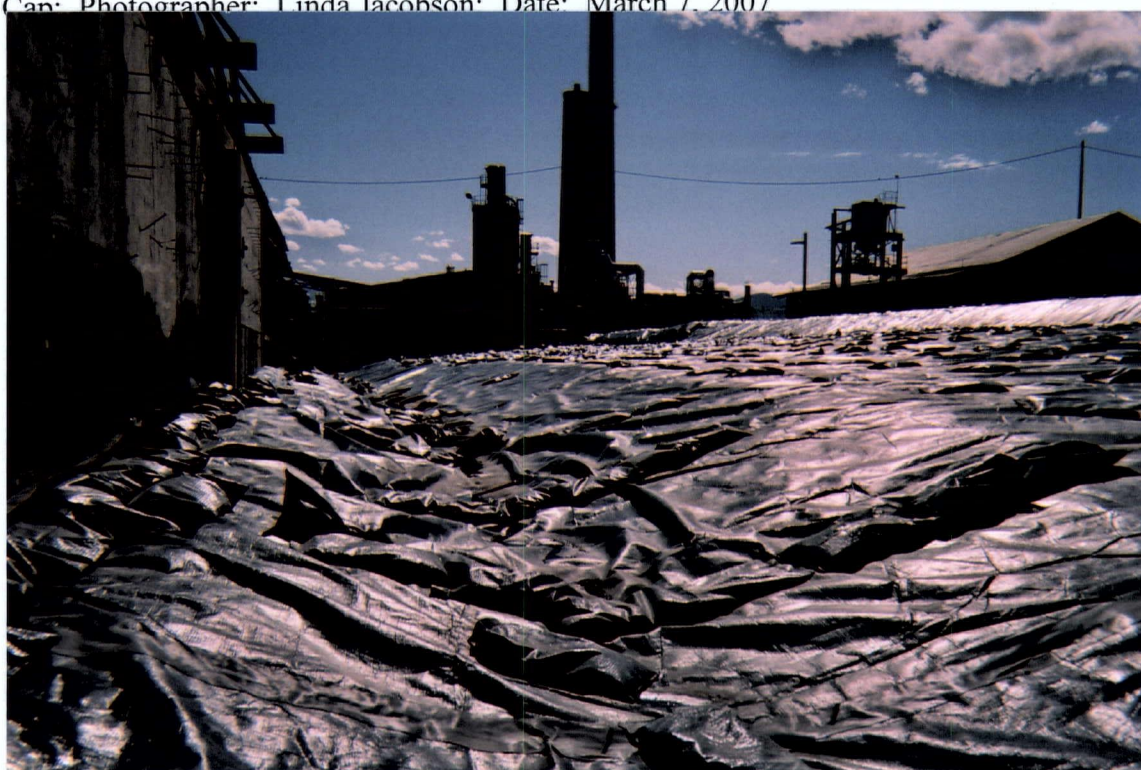
Roll 2, Photo 2; Facility: ASARCO East Helena Smelter; Subject: Sinter Plant Temporary Cap; Photographer: Linda Jacobson; Date: March 7, 2007

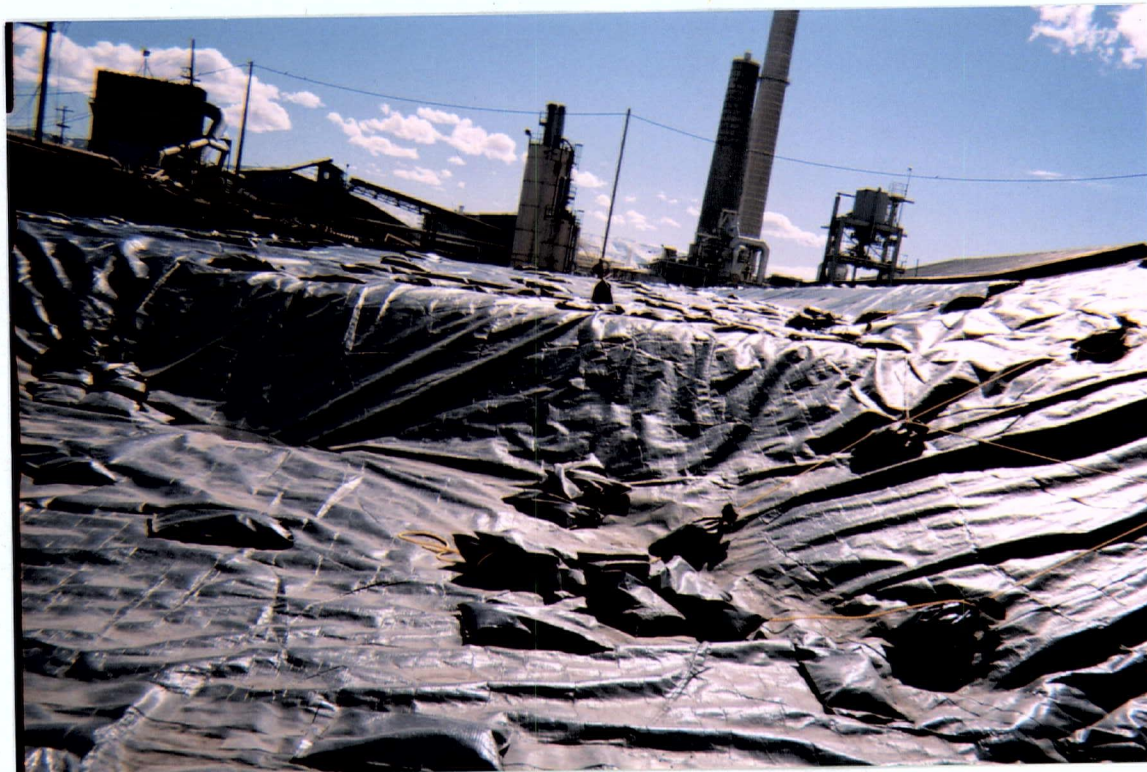
Roll 2, Photo 3; Facility: ASARCO East Helena Smelter; Subject: Sinter Plant Temporary Cap; Photographer: Linda Jacobson; Date: March 7, 2007

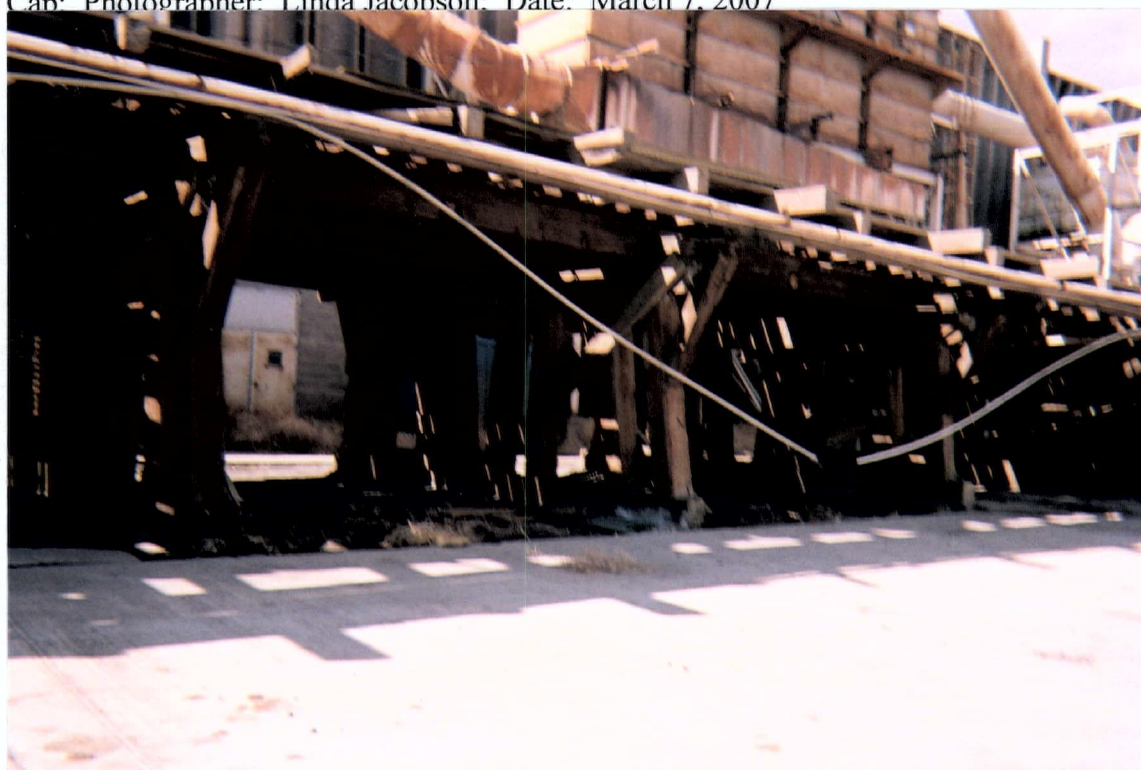
Roll 2, Photo 4; Facility: ASARCO East Helena Smelter; Subject: Highline Trestle; Photographer: Linda Jacobson; Date: March 7, 2007

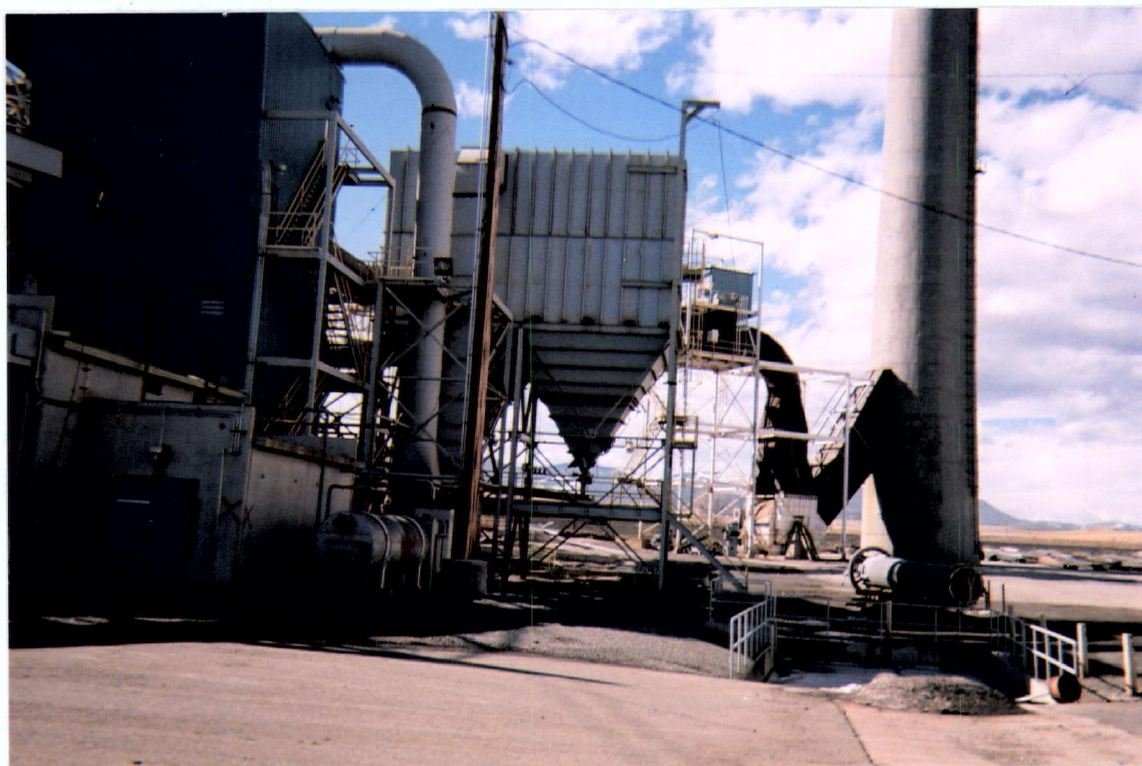
Roll 2, Photo 5; Facility: ASARCO East Helena Smelter; Subject: Baghouse Dust Collection System; Photographer: Linda Jacobson; Date: March 7, 2007

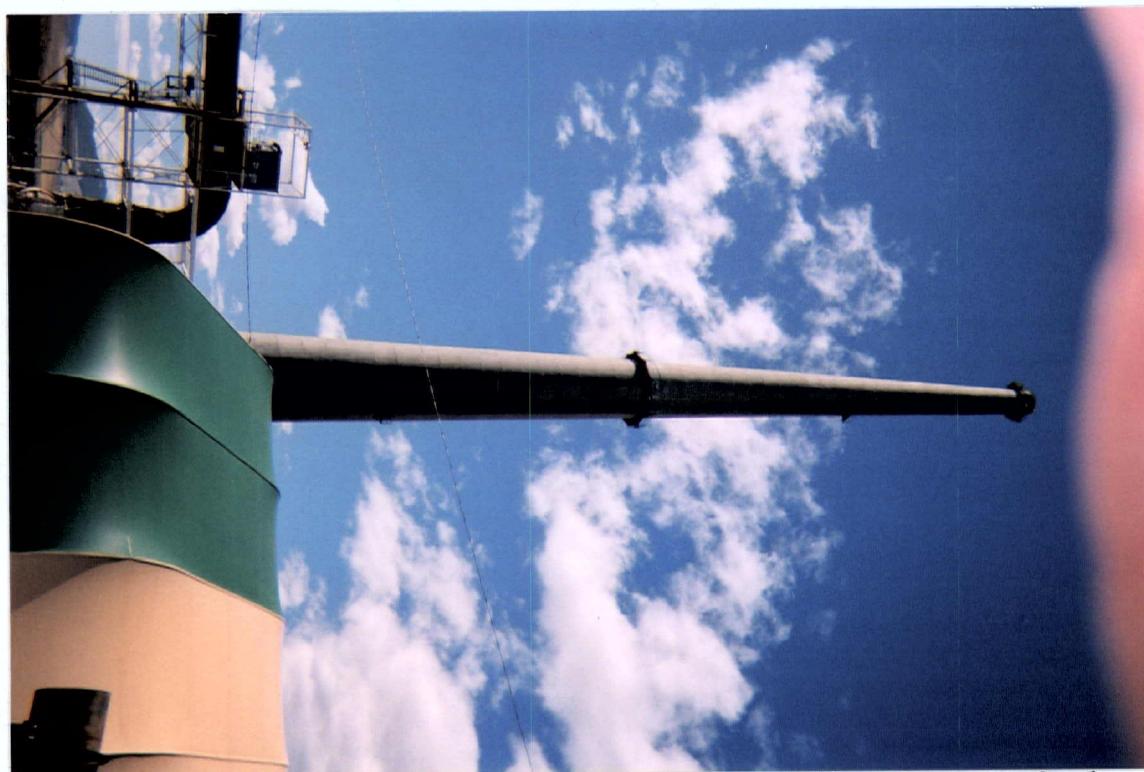
Roll 2, Photo 6; Facility: ASARCO East Helena Smelter; Subject: Baghouse Stack; Photographer: Linda Jacobson; Date: March 7, 2007

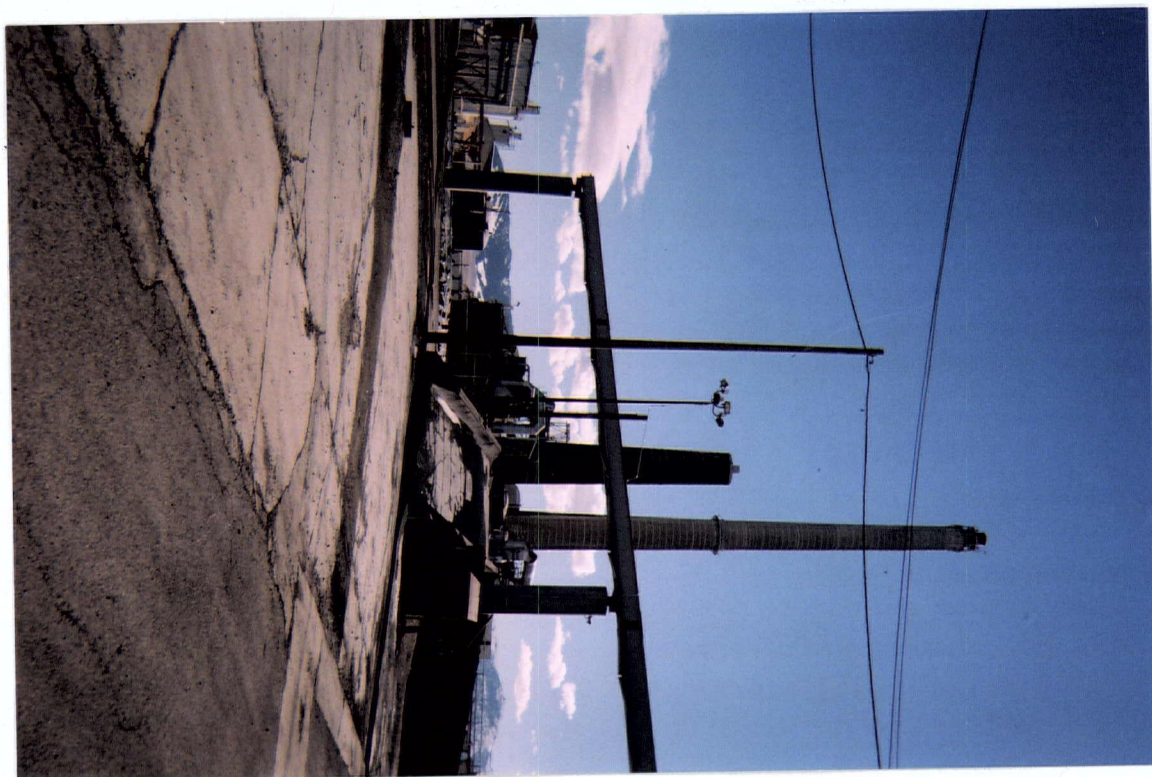
Roll 2, Photo 7; Facility: ASARCO East Helena Smelter; Subject: 420' Stack & Baghouse in Background; Photographer: Linda Jacobson; Date: March 7, 2007

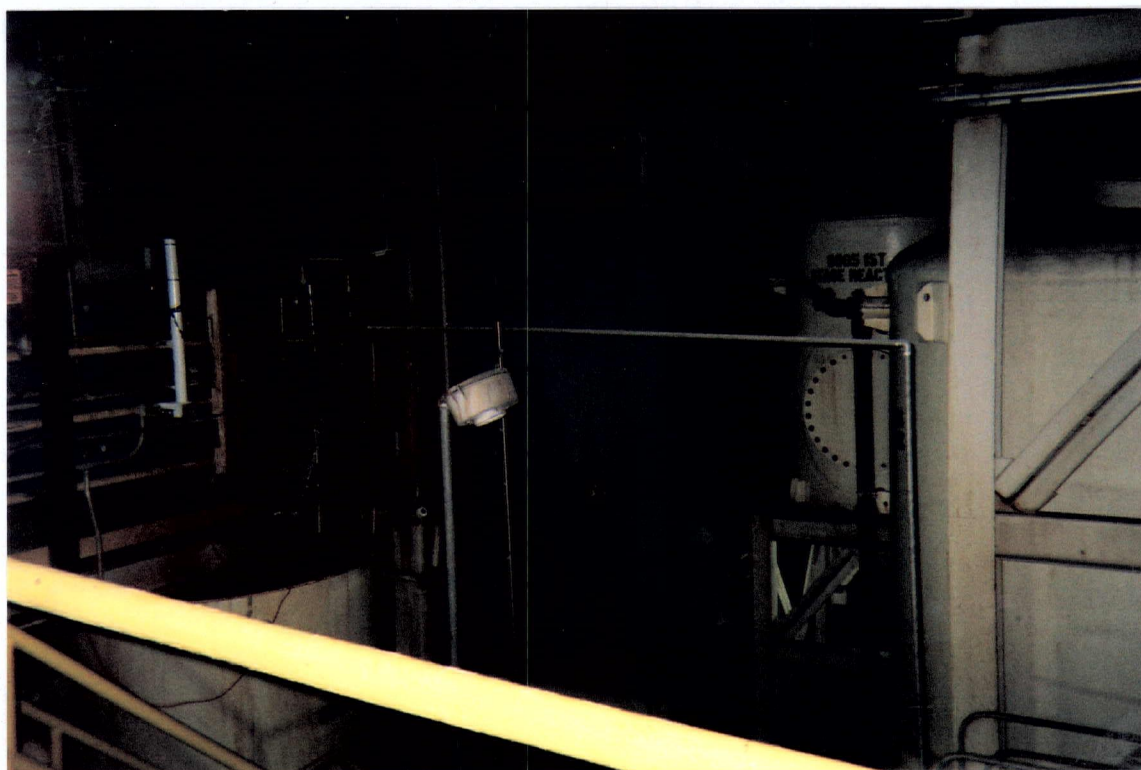
Ms. Jacobson was also shown the HDS wastewater treatment plant which is operated in a batch mode. Collected stormwater and other site generated waste waters are treated in this system, which has an MPDES discharge permit.

Roll 2, Photo 8; Facility: ASARCO East Helena Smelter; Subject: Wastewater Treatment System; Photographer: Linda Jacobson; Date: March 7, 2007

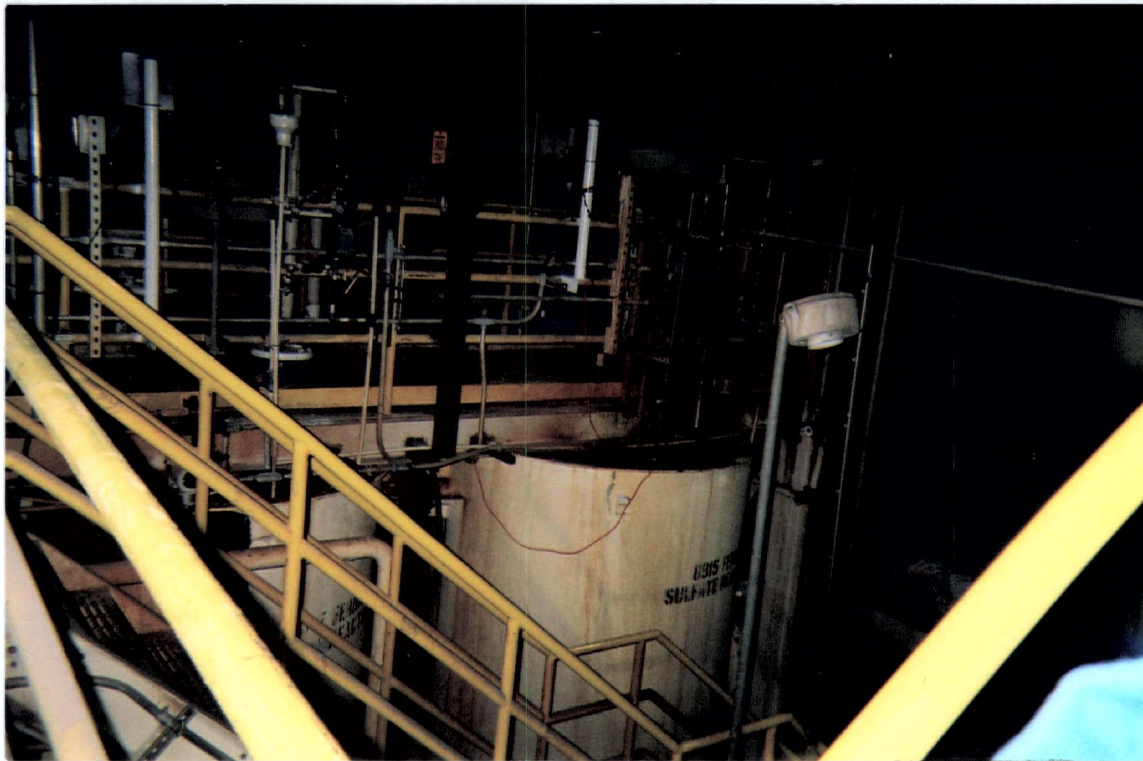
Roll 2, Photo 9; Facility: ASARCO East Helena Smelter; Subject: Wastewater Treatment System; Photographer: Linda Jacobson; Date: March 7, 2007

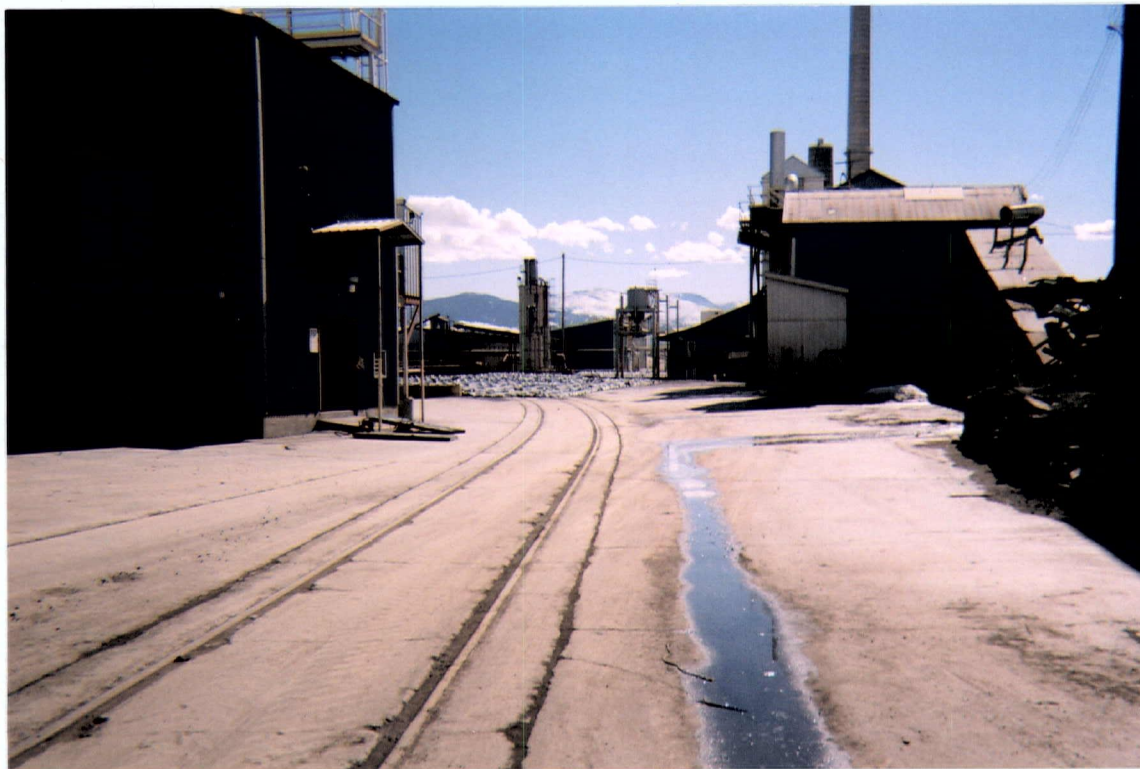
Roll 2, Photo 10; Facility: ASARCO East Helena Smelter; Subject: Remaining ASARCO Structures; Photographer: Linda Jacobson; Date: March 7, 2007

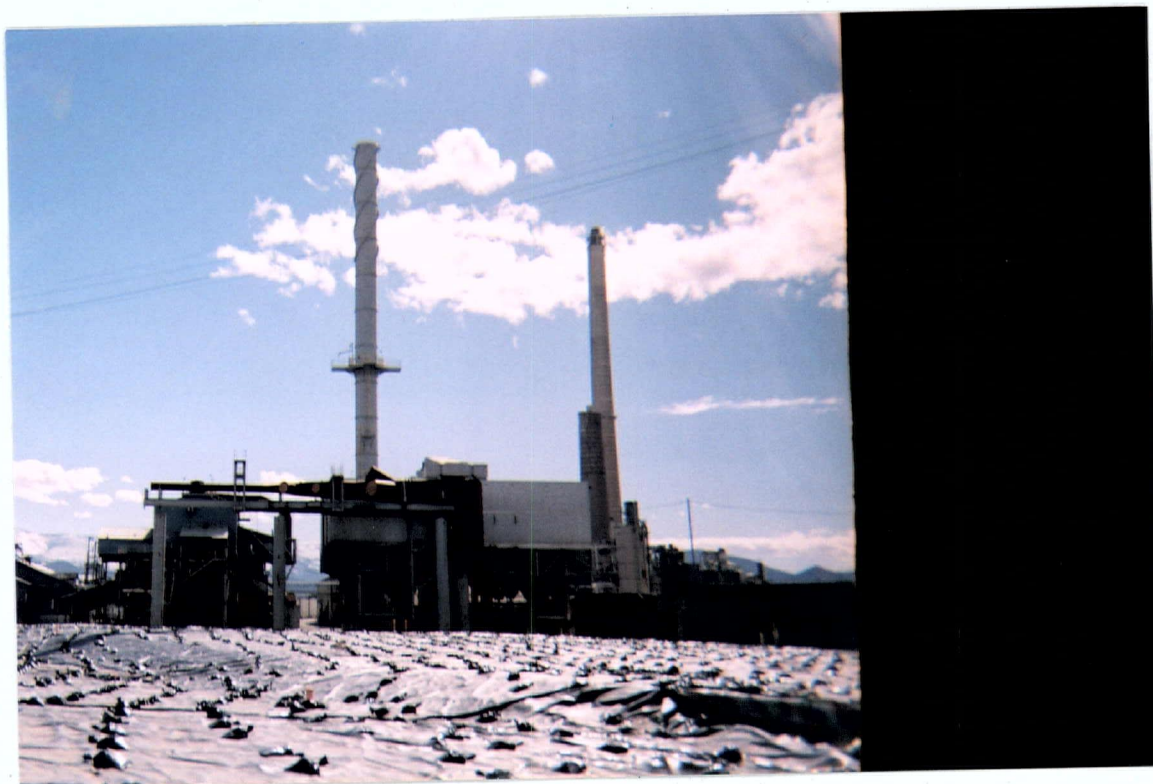
Roll 2, Photo 11; Facility: ASARCO East Helena Smelter; Subject: Dross Baghouse with Stacks in Background; Photographer: Linda Jacobson; Date: March 7, 2007

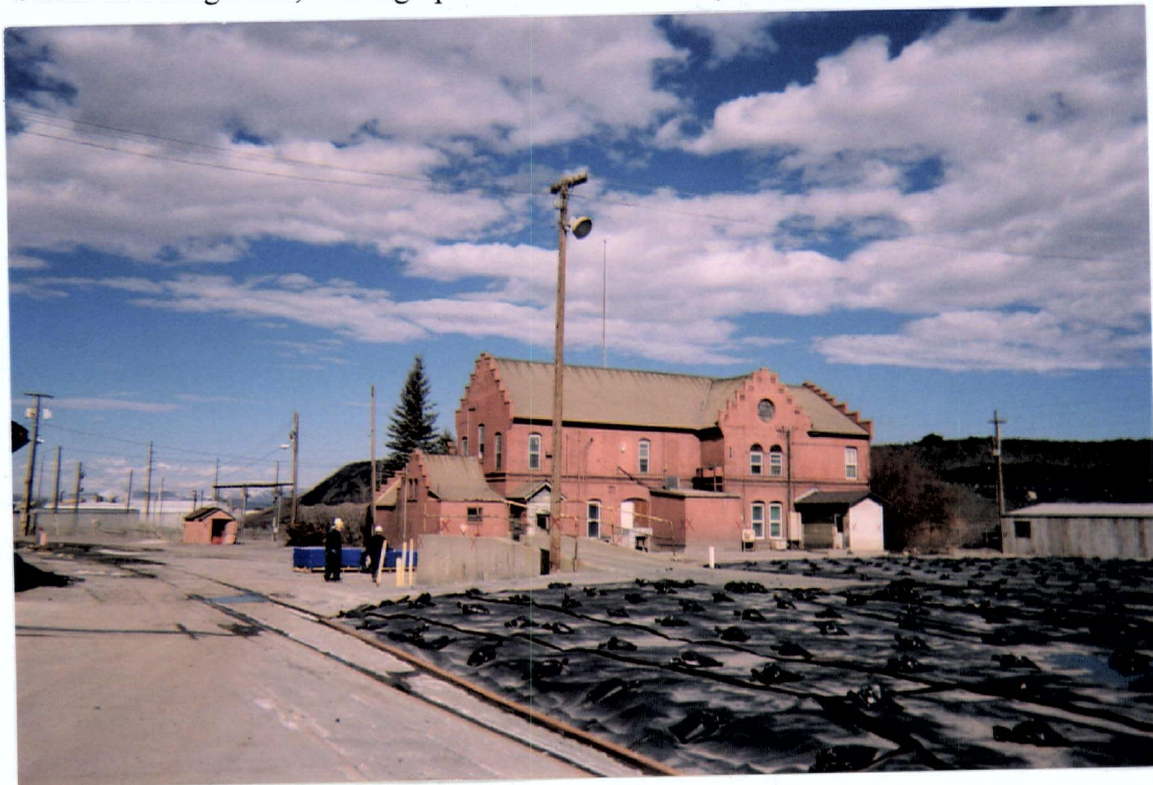
Roll 2, Photo 12; Facility: ASARCO East Helena Smelter; Subject: Administration Building with Temporary Cap in Foreground; Photographer: Linda Jacobson; Date: March 7, 2007
